Renal POCUS

Look For Evidence Of Hydronephrosis!

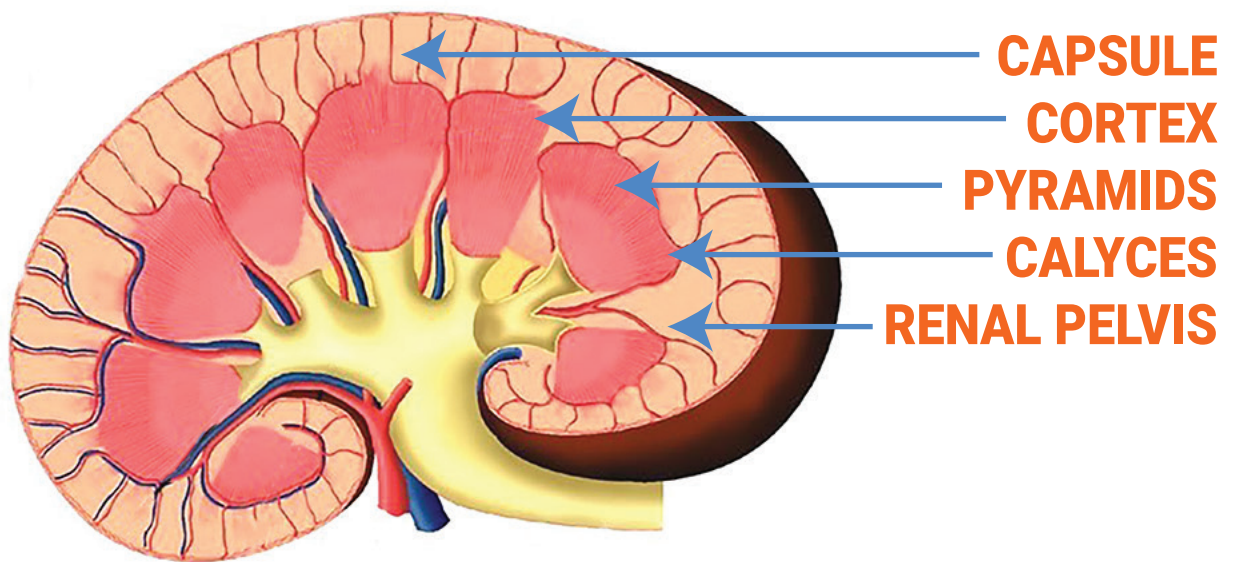
NORMAL ANATOMY →
 The Renal Pelvis is hyperechoic on ultrasound.

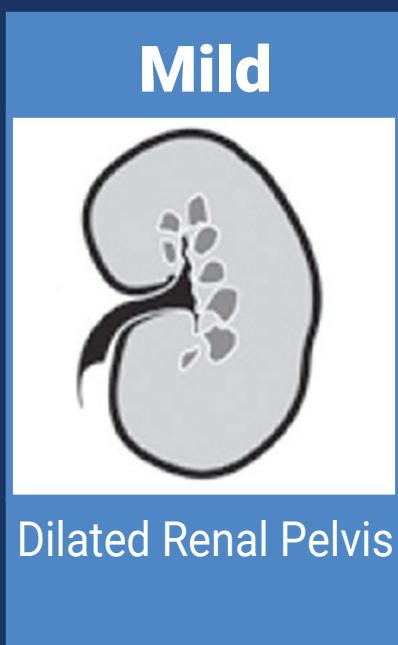
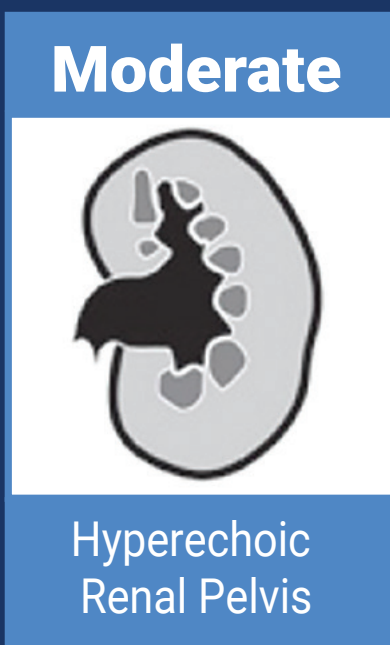
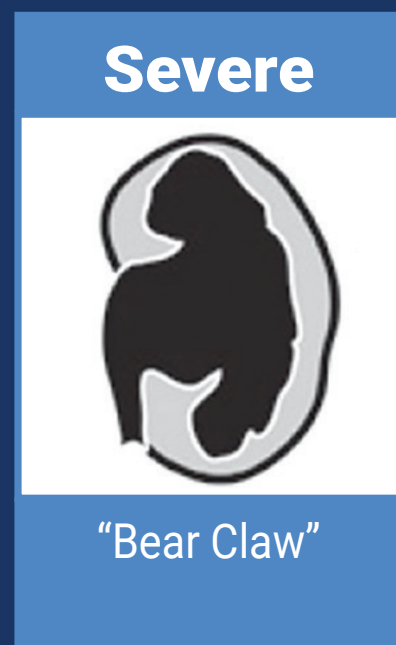
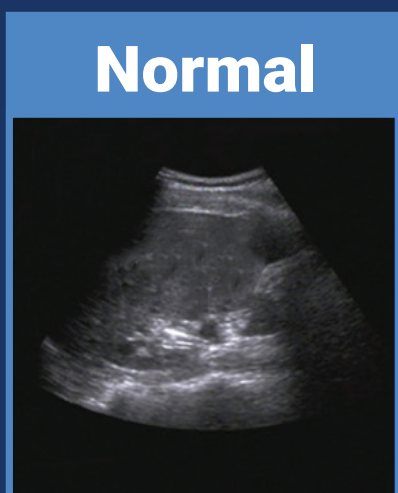
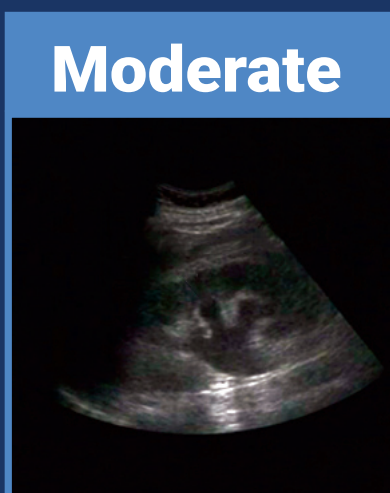
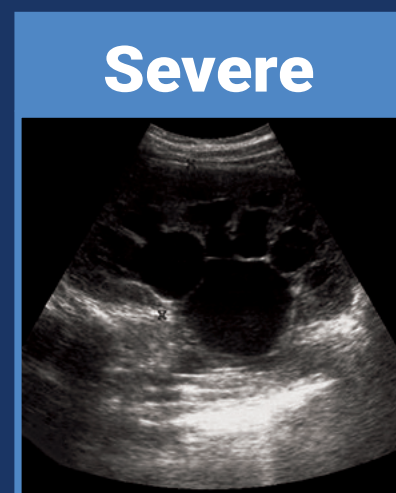
↑
Hydronephrosis
